## Philips redesigns burner for AM

*The production and maintenance of quartz burners was causing some trouble. That's why Philips decided to redesign the burners, with the help of Sirris' expertise in additive manufacturing.*

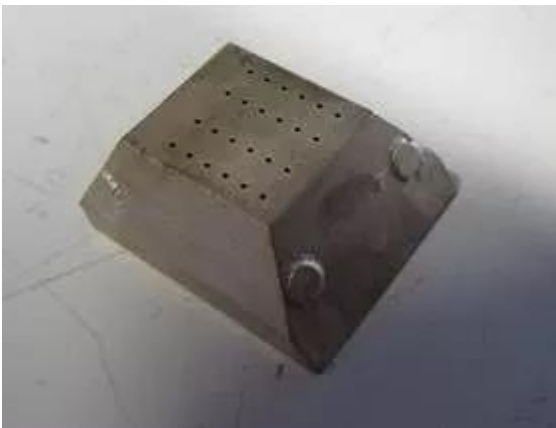
*Old burner*

The old burners were made from a copper alloy - to ensure proper cooling and because it allowed for brazing. However, the holes caused when the cooling channel was drilled, had to be closed.

The production of these burners met with quite some problems: it is not easy to make the drill holes watertight by means of brazing. When the first drill hole was soldered and the technician would

start on the second one, the first one would start to leak again because of the heat needed to solder the second one properly. When heating quartz, a lot of quartz fumes are released which are then deposited in cold places (for cooled burners). This meant the burners had to be cleaned (sandblasted) very often, which also caused the burners to leak.

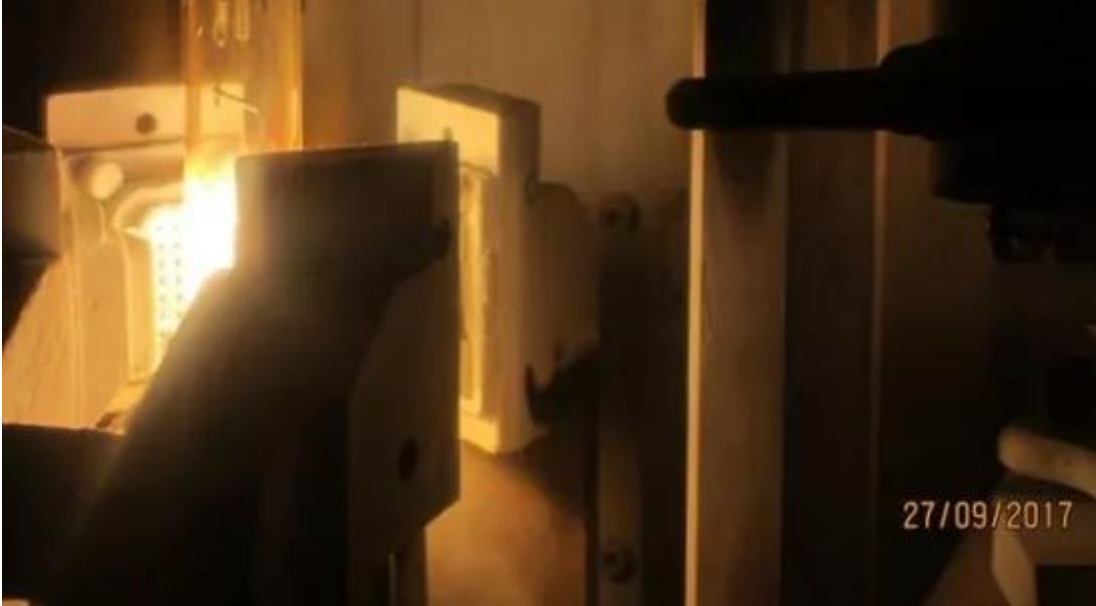
*The new burners in action*
