## Corrosion under insulation

### Testing of sensors and coatings in simulated industrial environment

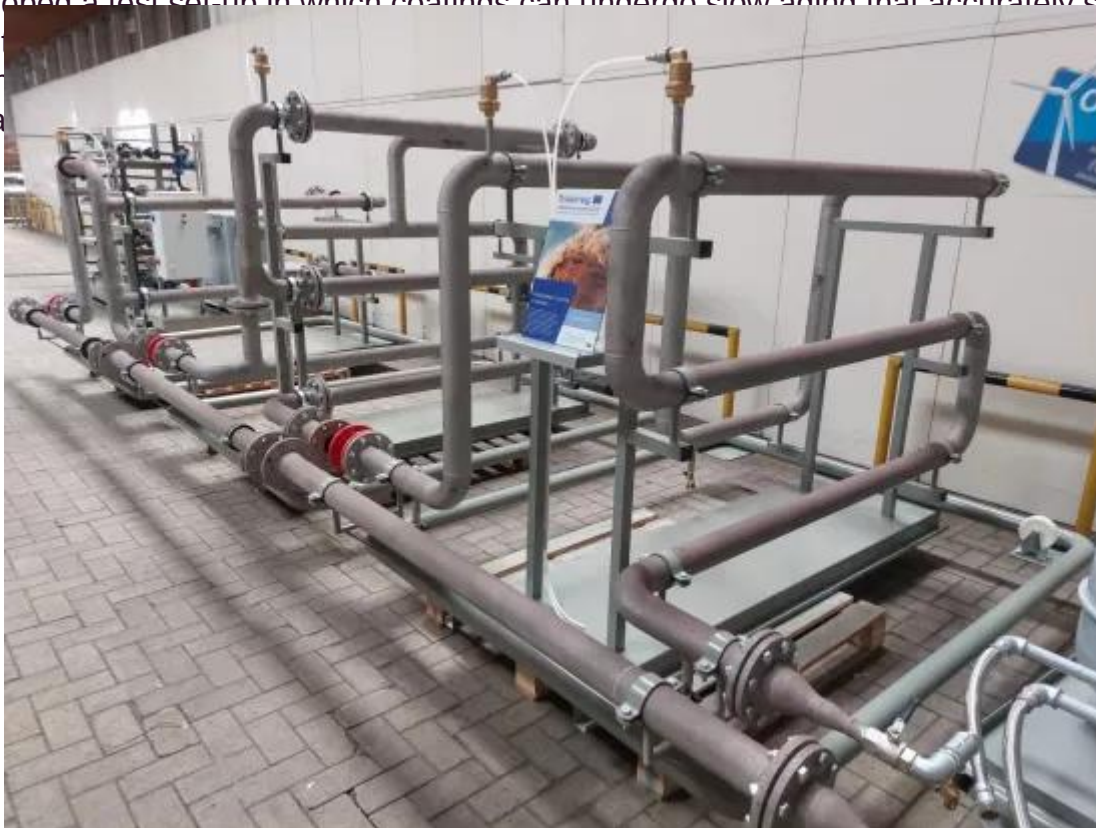
Test setup for evaluating coatings for COI on eight horizontal pipes (Photo taken before applying insulation)

Specifically, in the **development of new coatings** it is important to be able to evaluate the performance of coatings under various conditions. Today various international standards are available for this purpose, but the relevance of these tests for correctly assessing the useful life under field conditions is often a matter for debate. Therefore Sirris, in cooperation with Scalda, has developed a test set-up in which coatings can undergo slow aging that accurately simulates actual conditions. The test set-up is shown in the picture of the accelerated coating degradation.

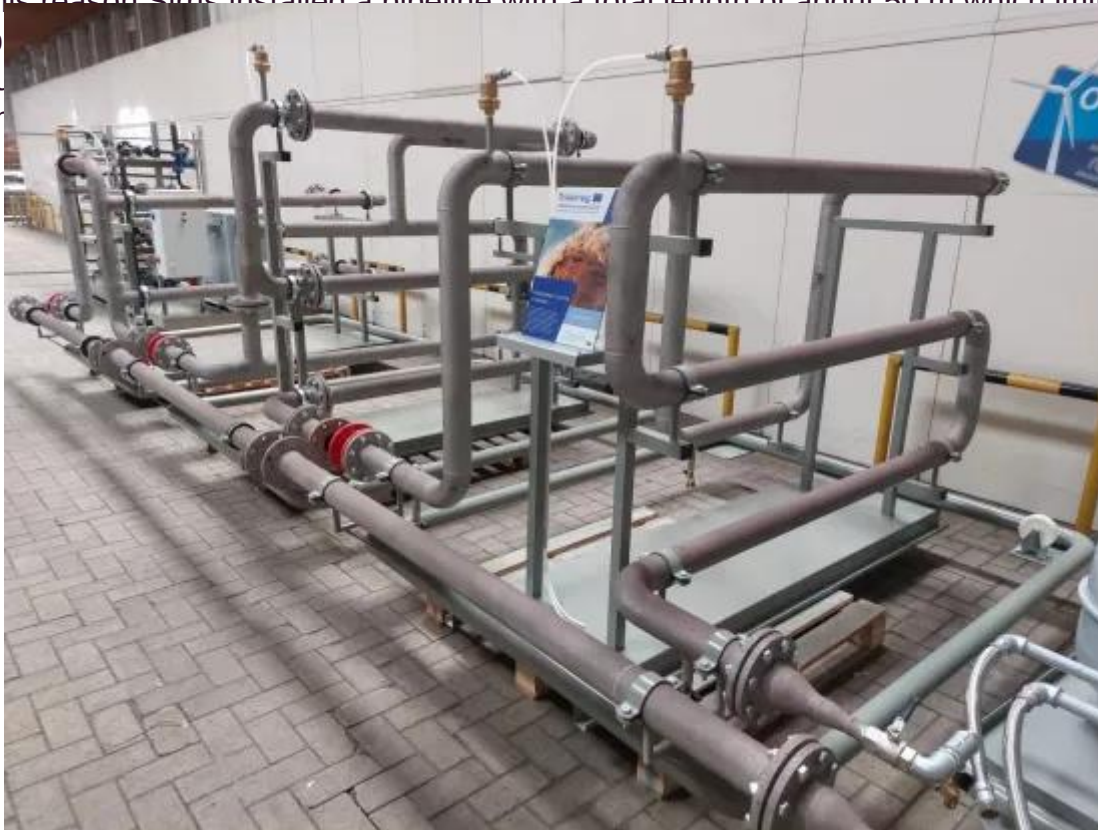
Test setup for evaluating sensors for COI. (Photo taken before applying insulation)

For this reason Sirris installed a pipeline with a total length of about 50 m which imitates the possibilities of various types of pipelines, including the possibilities of different types of sensors.
