# Benchmarking Study on Peelable Coatings

## Which peelable coatings are best suited to extend the lifespan of interior products?

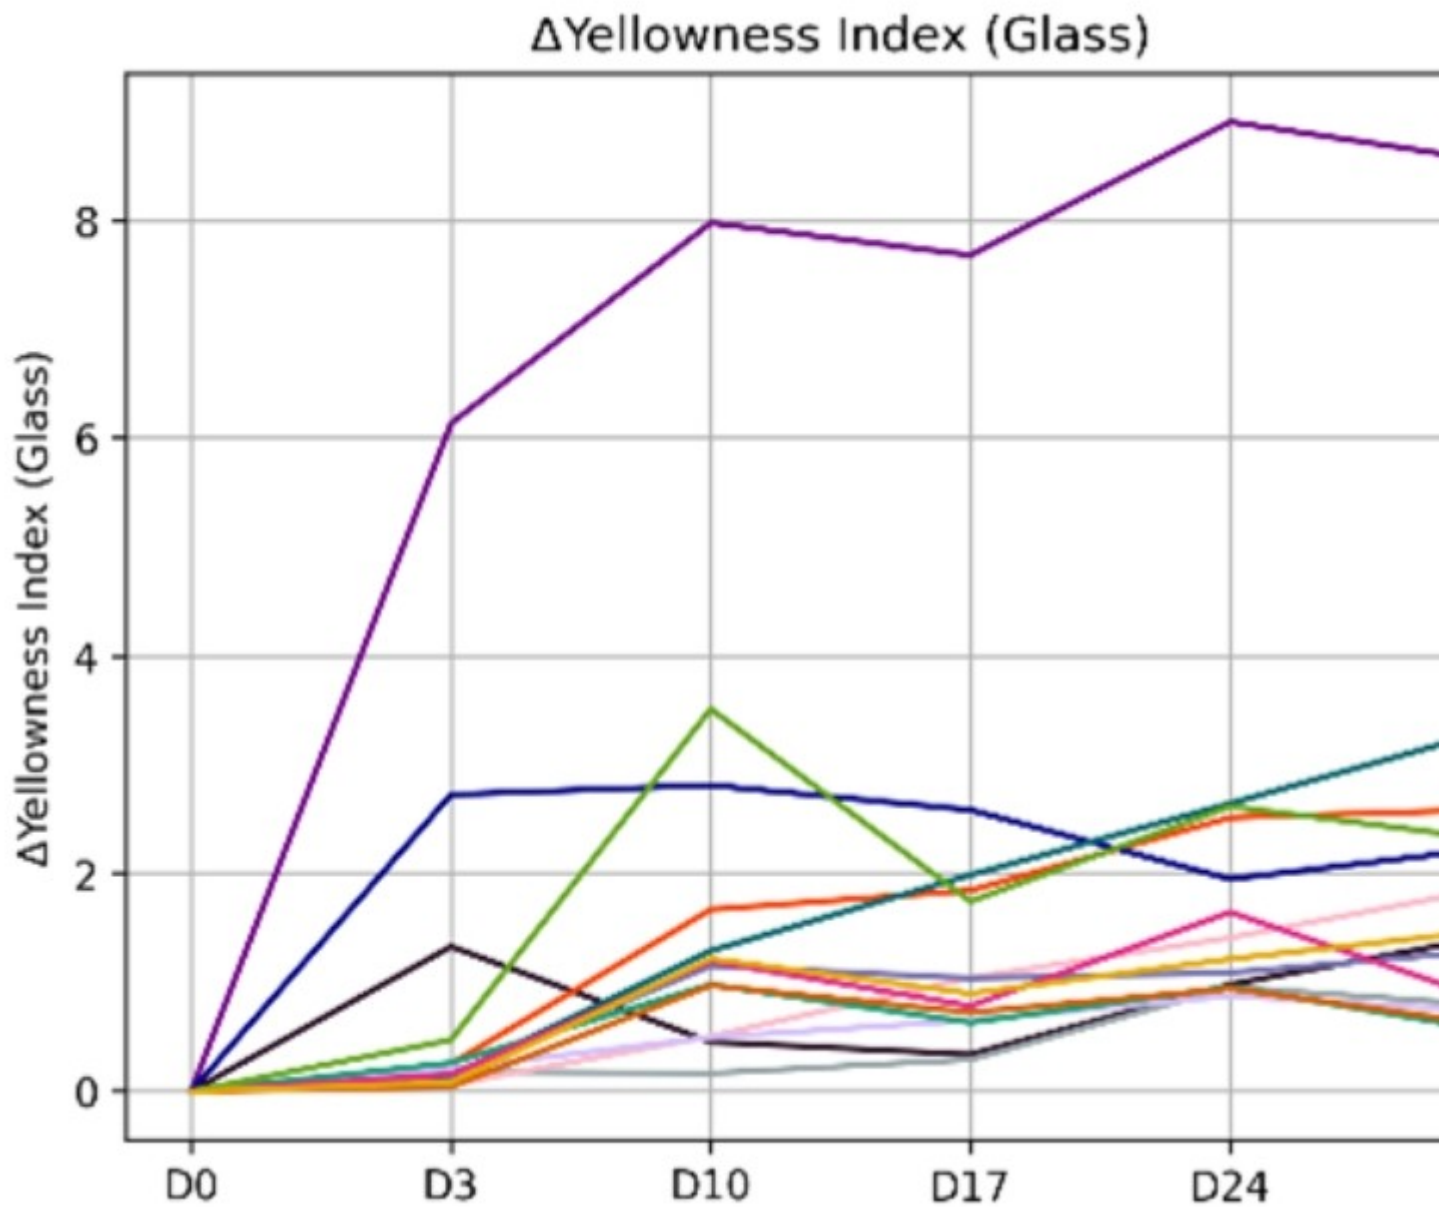
The **colour stability** of the coatings was assessed using the [Yellowness Index \( \$\Delta YI\$ \)](#), which measures yellowing and Delta E ( $\Delta E$ ), which quantifies the overall colour shift as the geometric distance between two points in the CIE Lab colour space. These parameters were used to evaluate the impact of UV exposure and accelerated climatic conditions on discolouration. For most coatings, both  $\Delta YI$  and  $\Delta E$  values remained at or below 3, indicating minimal yellowing and colour change throughout the aging protocol. However, Coating C showed a more pronounced increase in both  $\Delta YI$  and  $\Delta E$  during UV exposure, suggesting early-stage photodegradation, as well as a noticeable linear colour shift across the full aging duration.

| Code | A | B | C | D | E | F | G | H | L | N | P | Q | R | T |
|---|---|---|---|---|---|---|---|---|---|---|---|---|---|---|
| Color (ΔYI) | 1,4 | 2,6 | 8,5 | 2,2 | 3,3 | 0,8 | 1,9 | 0,7 | 0,6 | 0,6 | 1,3 | 0,8 | 2,3 | 1,5 |
| Color (ΔE) | 2,4 | 1,3 | 6,0 | 2,1 | 2,6 | 0,7 | 2,0 | 0,8 | 2,4 | 0,9 | 1,3 | 0,6 | 1,7 | 1,5 |

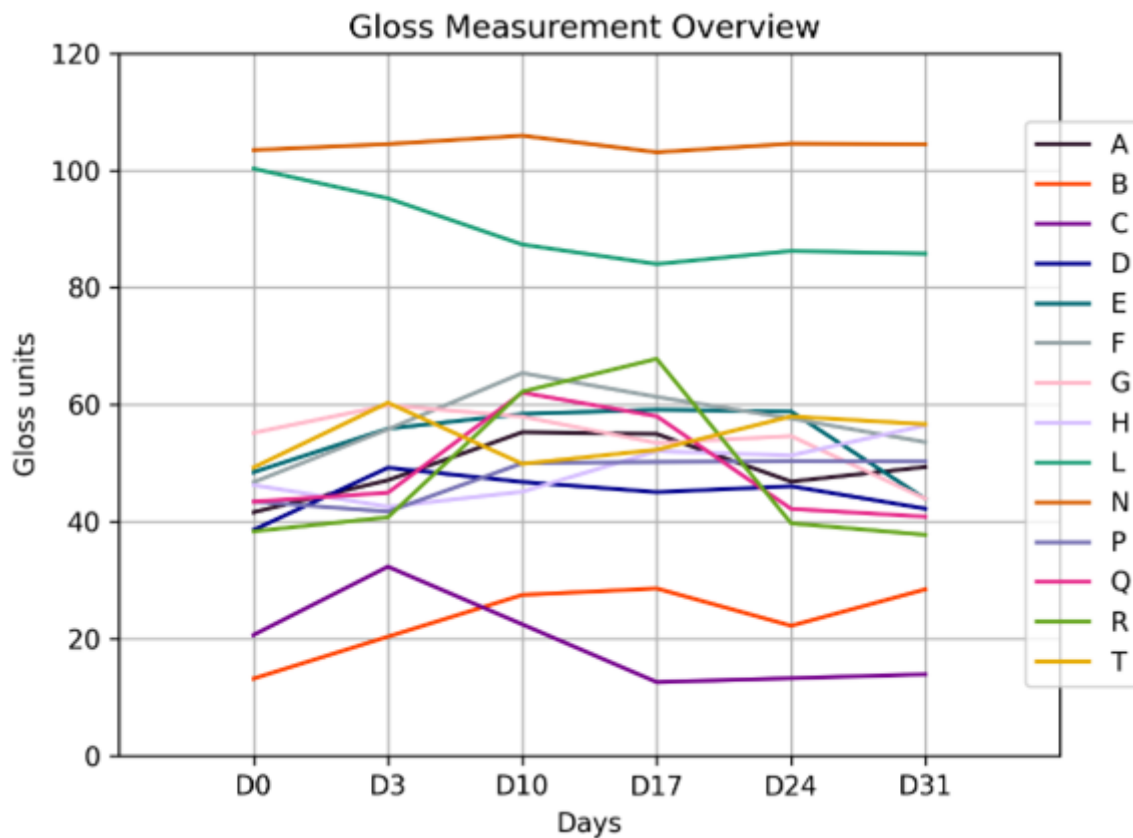
In cases where coatings became [slightly glossier](#), this effect was likely related to moisture absorption. Conversely, coatings that exhibited a gloss reduction likely experienced surface oxidation or related degradation processes.

| Code | A | B | C | D | E | F | G | H | L | N | P | Q | R | T |
|---|---|---|---|---|---|---|---|---|---|---|---|---|---|---|
| Gloss (ΔGU%) | -19% | -116% | 33% | -9% | 9% | -15% | 20% | -22% | 14% | -1% | -16% | 6% | 2% | -15% |

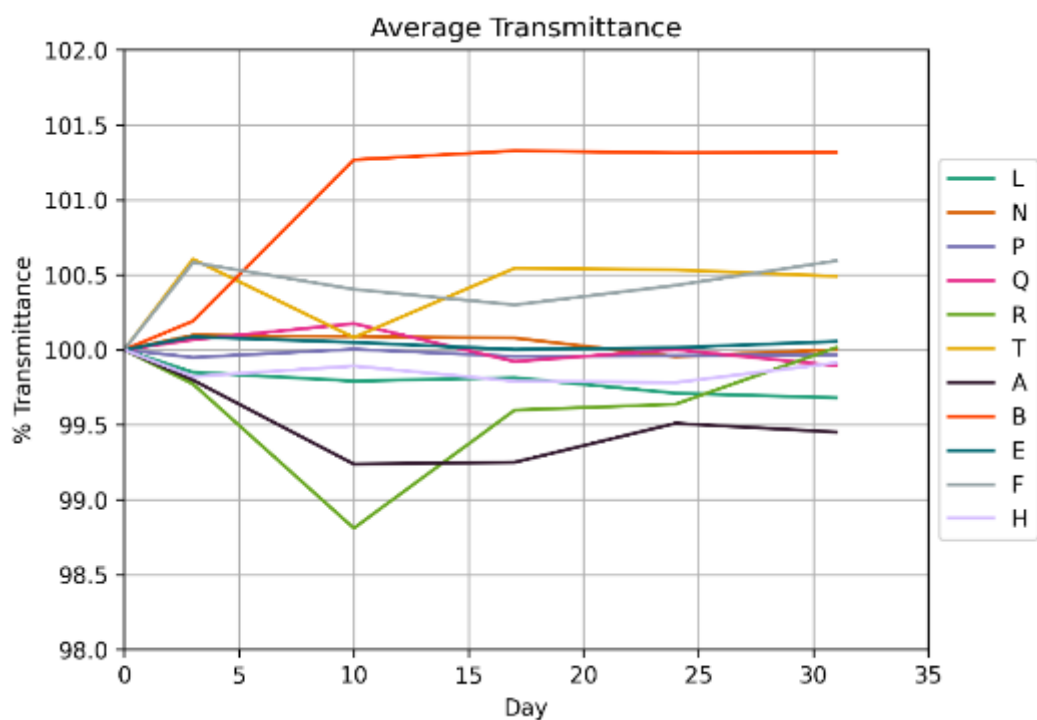
[Light transmittance measurements](#) were conducted for transparent coatings to evaluate changes in optical properties. Most coatings showed minimal variations, with Coating B exhibiting a slight improvement in clarity, while Coating A and L experienced a minor reduction in transmittance.

| Code | A | B | C | D | E | F | G | H | L | N | P | Q | R | T |
|---|---|---|---|---|---|---|---|---|---|---|---|---|---|---|
| Transmittance (%) | 76 | 85 | NA | NA | 89 | 89 | NA | 87 | 89 | 90 | 84 | 88 | 86 | 87 |
| Transmittance (Δ%) | 0,55% | 1,32% | NA | NA | 0,06% | 0,59% | NA | 0,09% | 0,32% | 0,00% | 0,04% | 0,11% | 0,01% | 0,49% |

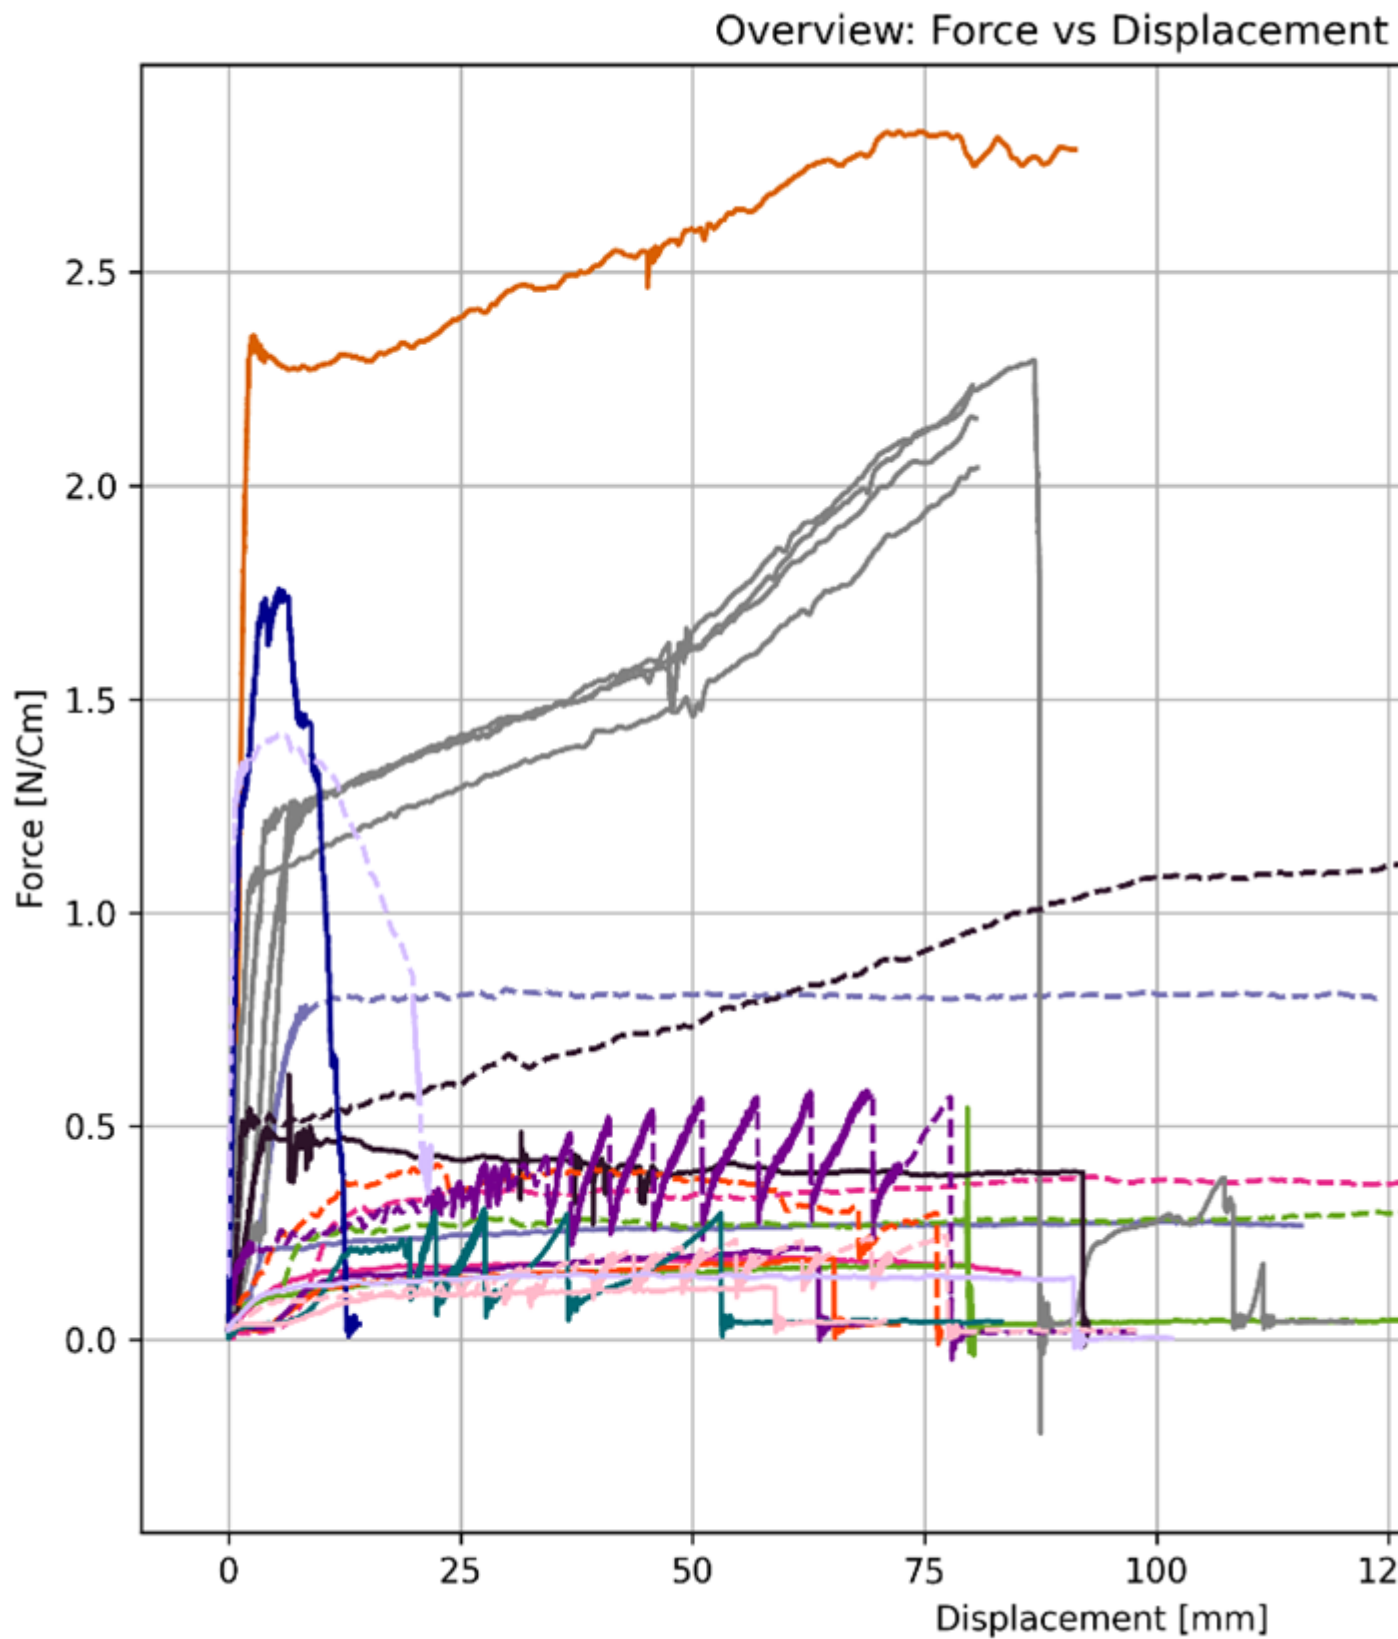
Figure 1: Graph of the force-displacement curves from peel tests performed on peelable coatings A to T and reference samples.

The above graph illustrates the force-displacement curves from [peel tests](#) performed on peelable coatings (A to T). The x-axis represents displacement (mm), while the y-axis denotes force (N/cm), measuring the resistance to detachment. Solid lines correspond to unaged samples, whereas dashed lines represent samples aged through UV exposure and accelerated climatic conditions.

To verify the ideal adhesion strength using this testing protocol, a practical reference was selected by the project partners. Sandwich panels that are often used by the partners are delivered with a protective film applied to the surface. Removing this film requires some effort but is still manageable, making it a suitable benchmark for acceptable peelability. A sandwich panel with its original protective film was cut to the same size as the test samples and evaluated using the same peel test protocol. The resulting peel force was measured at 1.2 N/cm. Within this study, only Coating N achieved a peel force exceeding that of the reference sample, which indicates this coating would be too difficult to peel off. All other coatings demonstrated significantly lower peel force, which indicates they probably would peel off too easily.

The force pattern provides insights into peeling behaviour. A zigzag pattern suggests shock-like detachment, indicating non-uniform adhesion. In contrast, coatings with a stable force curve detach smoothly, ensuring a controlled peeling process. These variations highlight differences in adhesion strength, material integrity and resistance to aging effects.

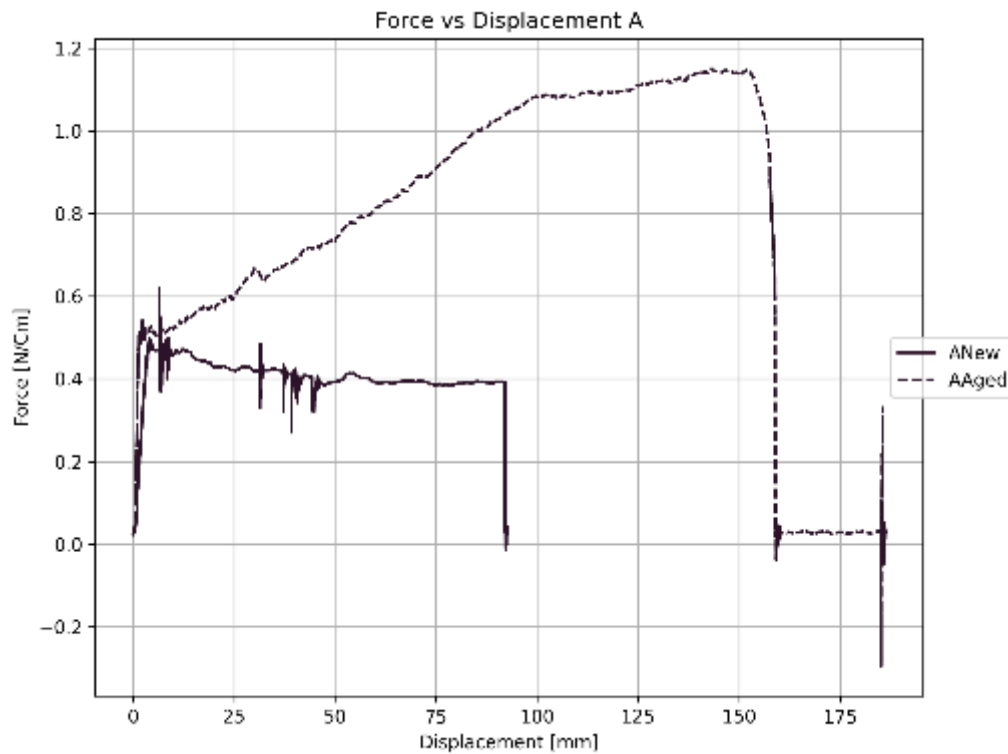
In its unaged condition, **Coating A** demonstrates a relatively low (0.5 N/cm) and stable peel force, indicating controlled detachment. The displacement extends over 90 mm, meaning the coating remains intact throughout most of the peeling process. After aging, the sample exhibits no significant difference in the initial peel force, but the force gradually increases over the displacement, surpassing 150 mm. This suggests that aging increased the cohesion or increased the adhesion to the substrate to a higher value than the internal cohesion of the coating, causing the coating to elongate during peeling rather than detach cleanly.

Figure 2: The force-displacement curves from peel tests performed on coating A.

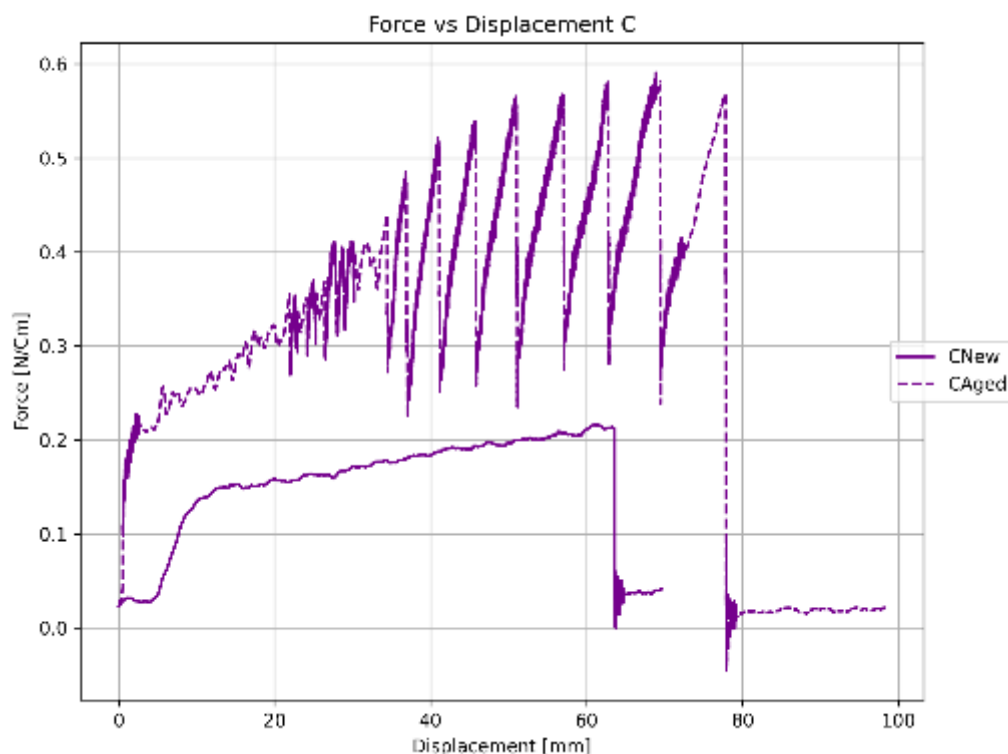
**Coating C** exhibits distinct peeling behaviour before and after aging. The unaged sample peels smoothly with a peel force of 0.1 N/cm but ruptures at 65 mm. In contrast, the aged sample follows a zigzag pattern, indicating shock-like detachment. The peak force increases to 0.2 N/cm and failure occurs at 80 mm, suggesting that aging enhances adhesion while also increasing stiffness, leading to an irregular peeling pattern.

Figure 3: The force-displacement curves from peel tests performed on coating C.

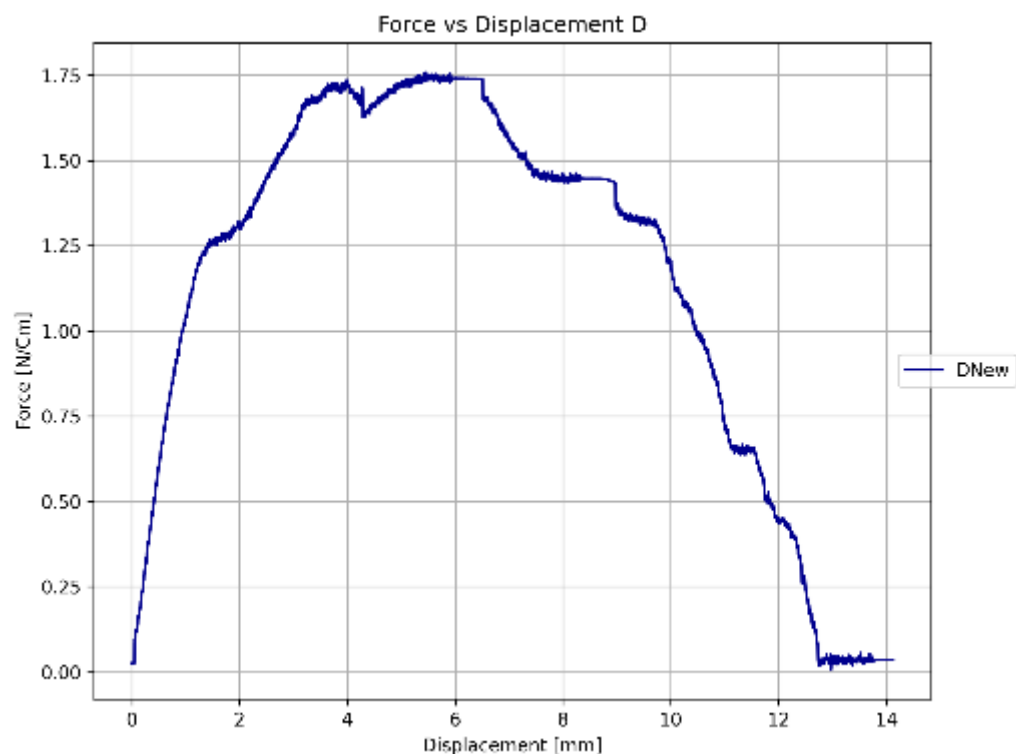
**Coating D** shows a high initial peel force exceeding 1.4 N/cm but fails almost immediately, with displacement limited to less than 20 mm. This suggests that the coating rips instead of peeling, indicating insufficient cohesion. After aging, the sample was even weaker and could not be peeled off, implying significant degradation due to UV exposure and climatic aging.

Figure 4: The force-displacement curve from peel test performed on coating D.

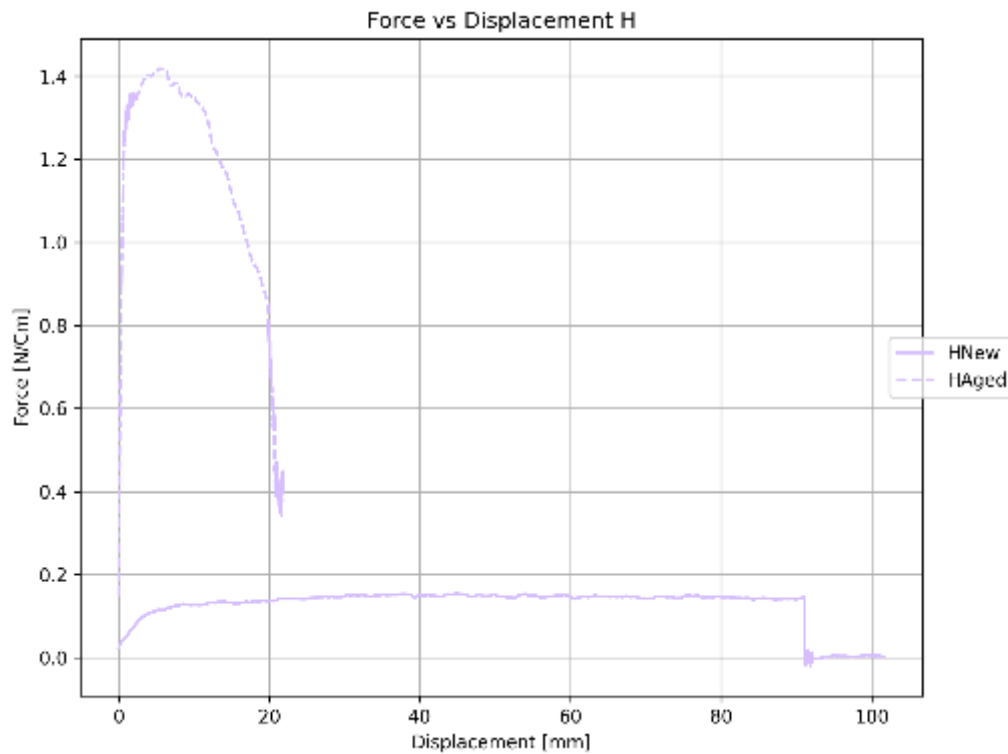
**Coating H** exhibits a low (0.1 N/cm) and stable peel force in the unaged condition, suggesting controlled detachment. However, after aging, the peel force increases significantly, while displacement is limited to 20 mm. This indicates that aging caused embrittlement, increasing adhesion strength but reducing flexibility, ultimately leading to premature failure during peeling.

Figure 5: The force-displacement curves from peel tests performed on coating H.

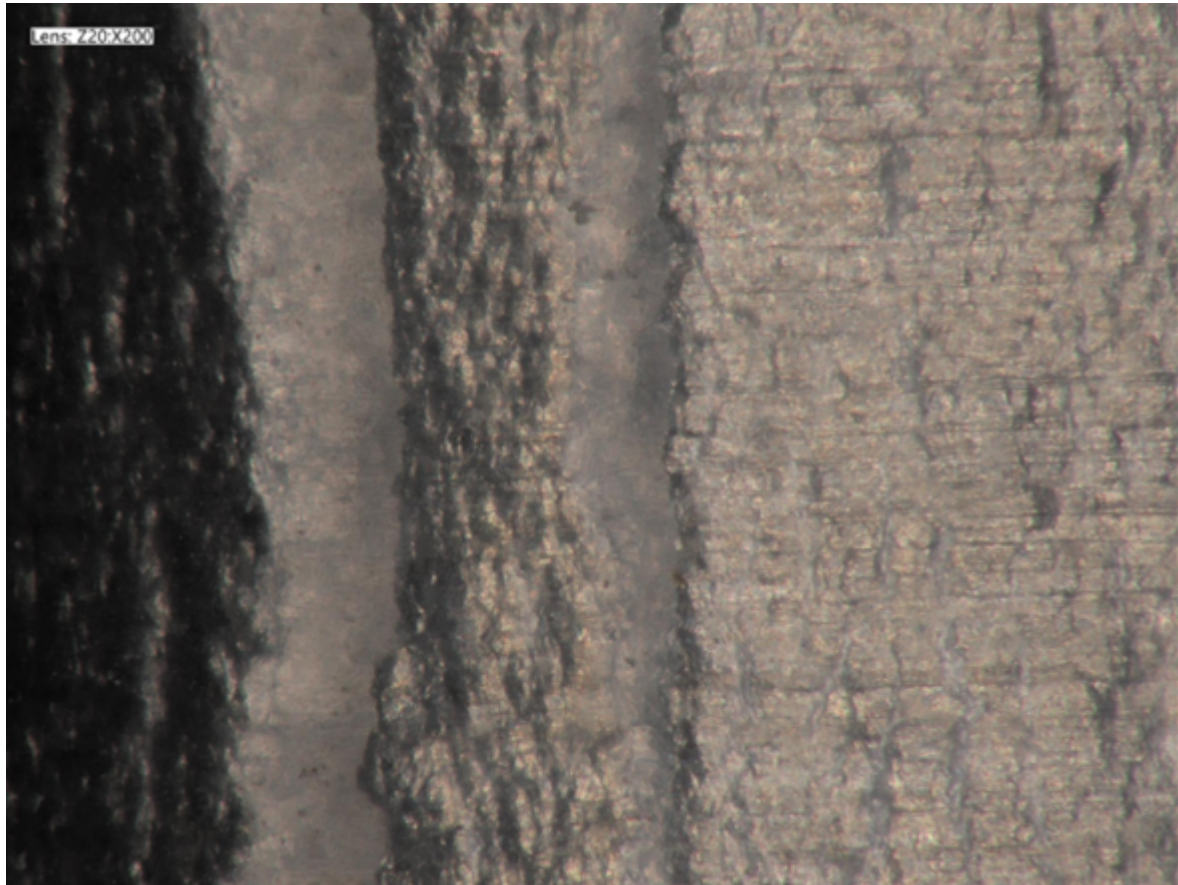
Figure 6: Microscopic images of the non-aged and aged Coating A samples show that the coating webs over the substrate crack at T0.

Flexibility was assessed using the [T-Bend Test](#), which measures a coating's ability to bend without cracking or losing adhesion. A flat, rectangular specimen is bent 360° and the resulting bend rating (Tf) indicates the number of bends that can be performed without observing any failure in the coating, such as cracking or delamination. This test was conducted on both aged and non-aged samples. Most coatings demonstrated exceptional flexibility with a T0 rating (no damage with the initial bend), having high stretchability and adhesion even when the substrate cracked. However, **Coating D** exhibited minor cracking at the tightest bend, receiving a T1 rating, indicating slightly lower flexibility.

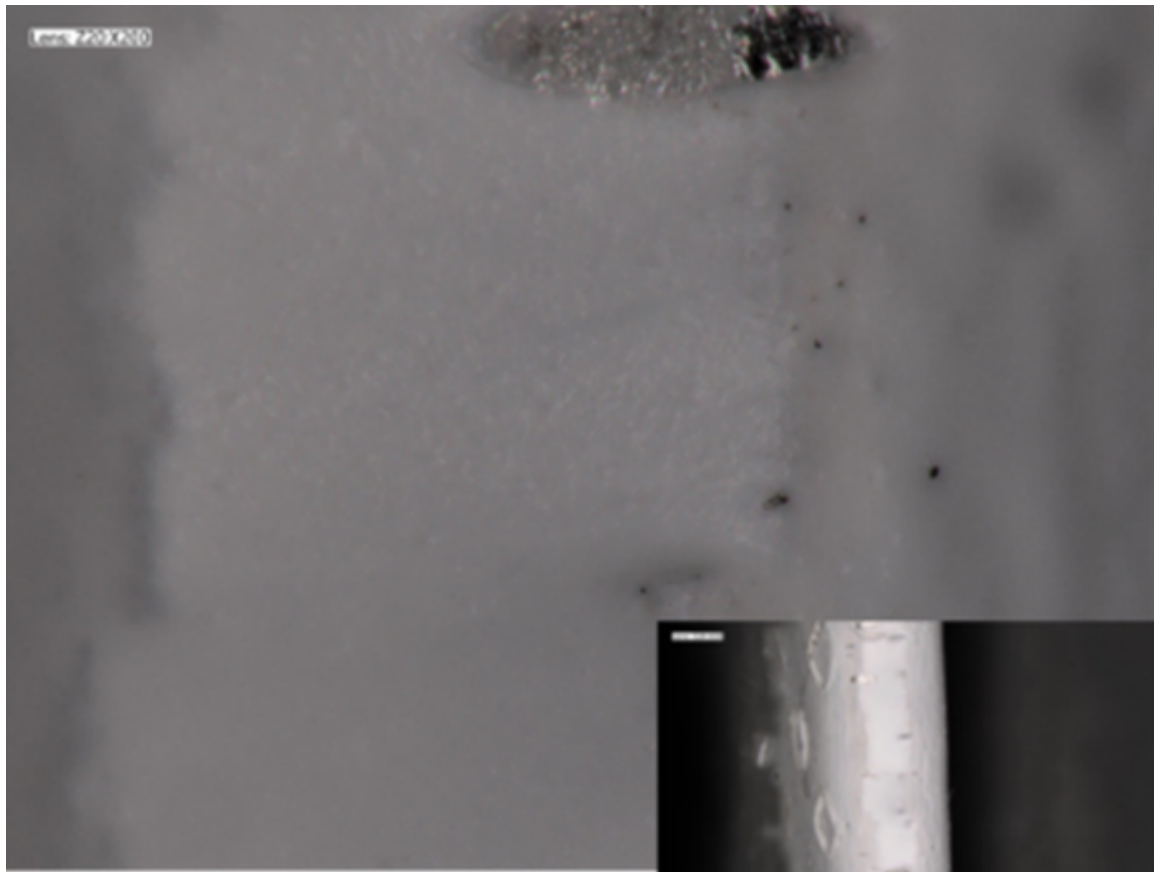
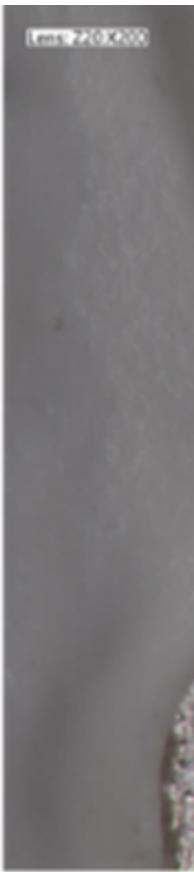
Figure 7: Microscopic images of the non-aged and aged Coating D samples show that the coating rips at T0.

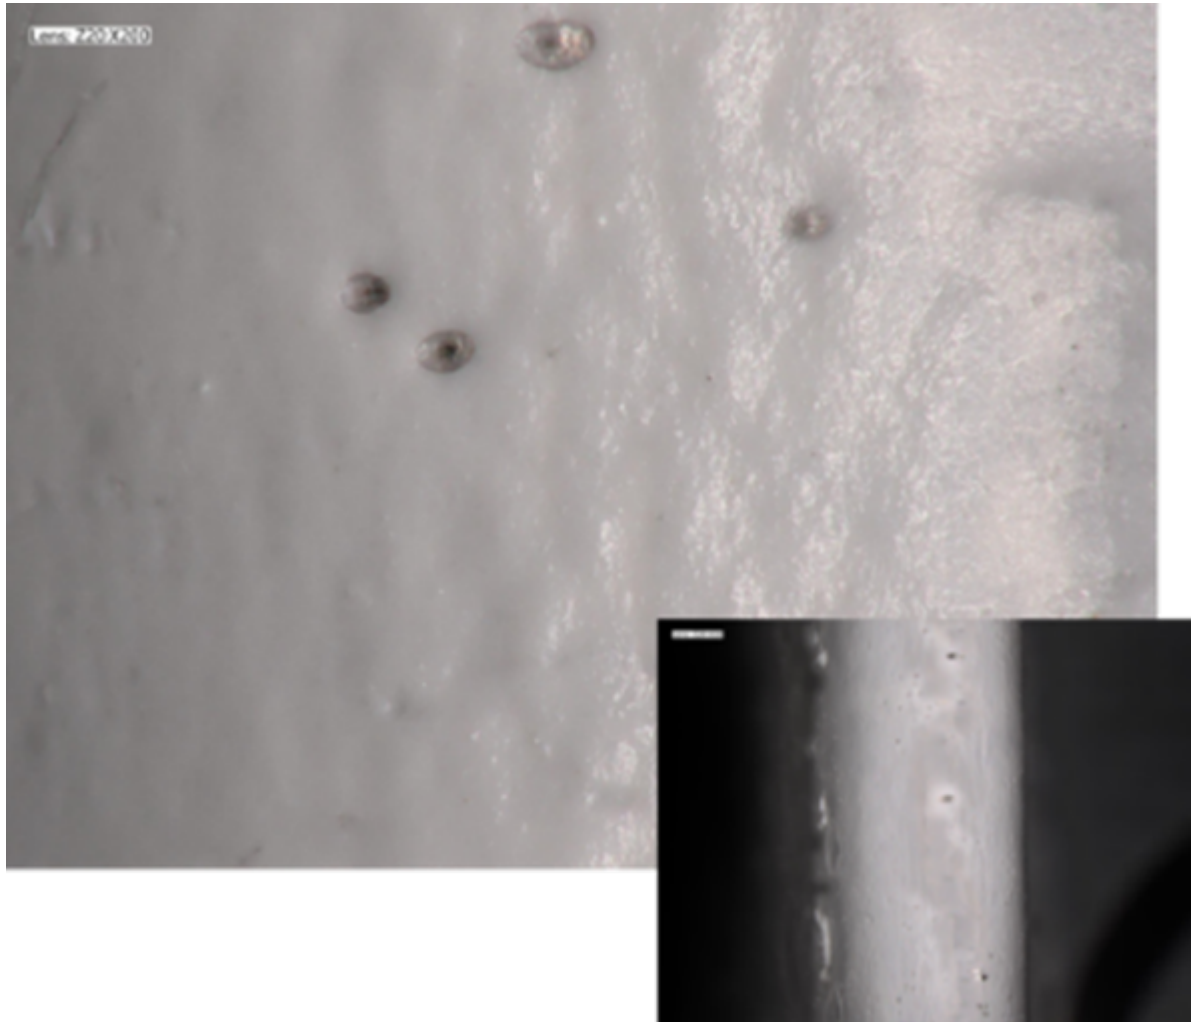
Figure 8: Microscopic images of the non-aged and aged Coating D samples show that the coating stays intact at T1.

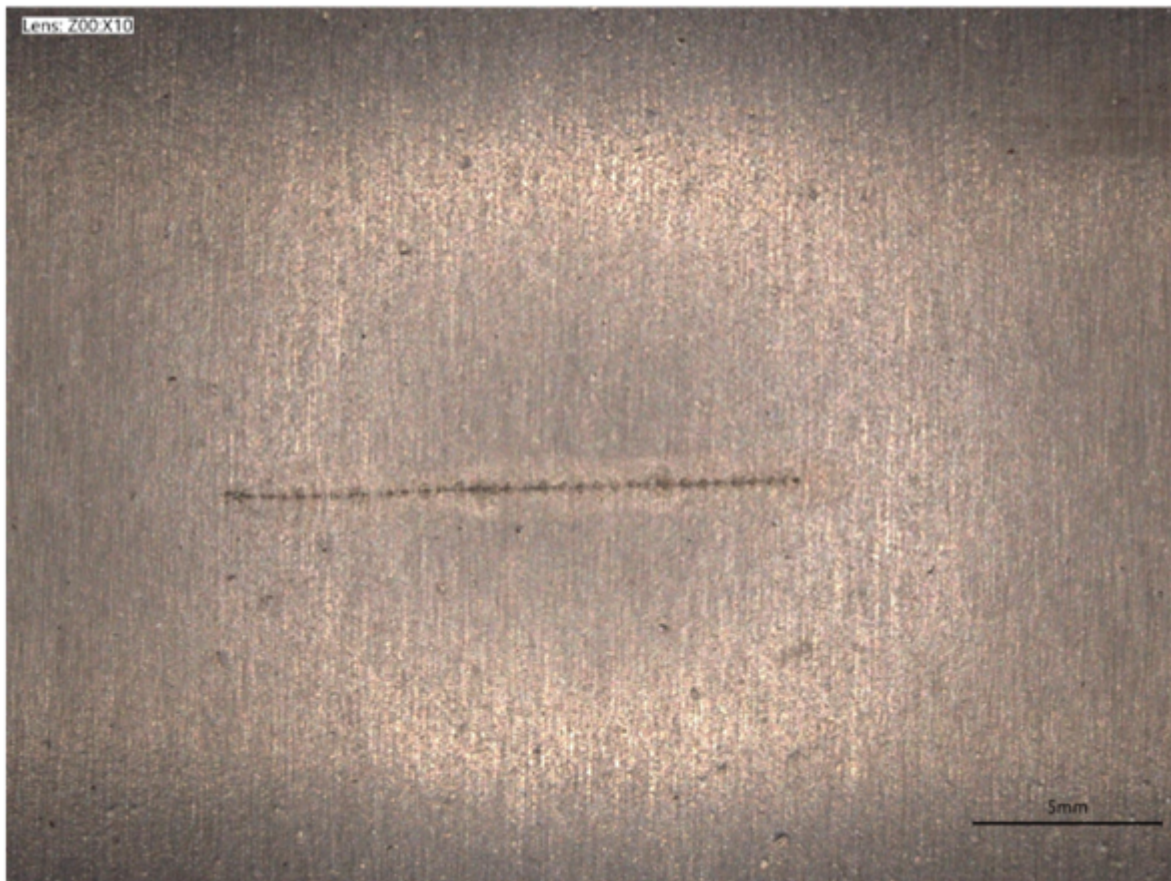
Scratch resistance was assessed on both aged and non-aged samples to evaluate the [effect of aging on surface hardness and durability](#). The test involved applying a controlled force, based on the minimum required to produce a visible scratch on the non-aged sample, using a precision tool. The same force was then applied to the aged sample for direct comparison. Across all coatings, scratches were less pronounced after aging, indicating increased hardness or stiffness over time. This behaviour suggests that UV radiation and accelerated climatic conditions induce structural changes. While these changes enhance scratch resistance, they may also contribute to greater brittleness over time. Microscopic analysis of **Coating P** illustrates this trend: the non-aged sample exhibited visible delamination around the scratch, whereas the aged sample showed no delamination, reflecting improved surface integrity after aging.

Figure 9: Microscopic images of the scratch on the non-aged and aged Coating P samples.

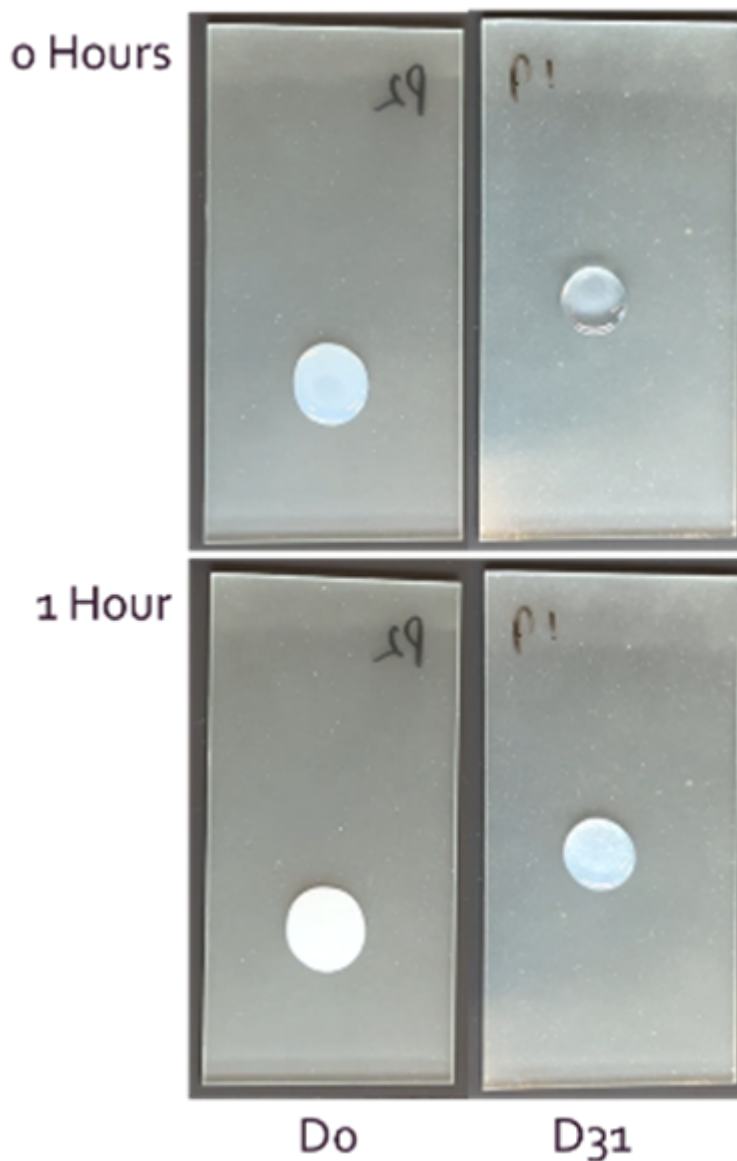
Most coatings exhibited some degree of interaction with water, though the severity varied. **Coatings L and N** showed no visible effect upon exposure. In contrast, the other coatings appeared to "dissolve" or soften when in contact with water; however, this effect was reversible. Once the water was removed and the coatings were allowed to dry, they returned to their original state. This indicates that while these coatings may temporarily lose mechanical integrity during water exposure, they do not sustain permanent damage.

Figure 10: Photographs of the non-aged and aged Coating P samples at different time intervals during the chemical resistance test.

The [chemical resistance](#) of the coatings was evaluated to assess their ability to withstand exposure to different products. The test involved applying three different substances: body lotion, water and a cleaning solution, to the coating surfaces and observing any visual or structural changes after exposure. The results indicate that they were primarily affected by water.
