## Ten most common wind turbine failure issues identified

*The analysis of the data of some 7,000 wind turbines has revealed the main problems causing downtime and, therefore, lost potential energy production when the wind turbine is out. Many of these problems can be solved or prevented.*

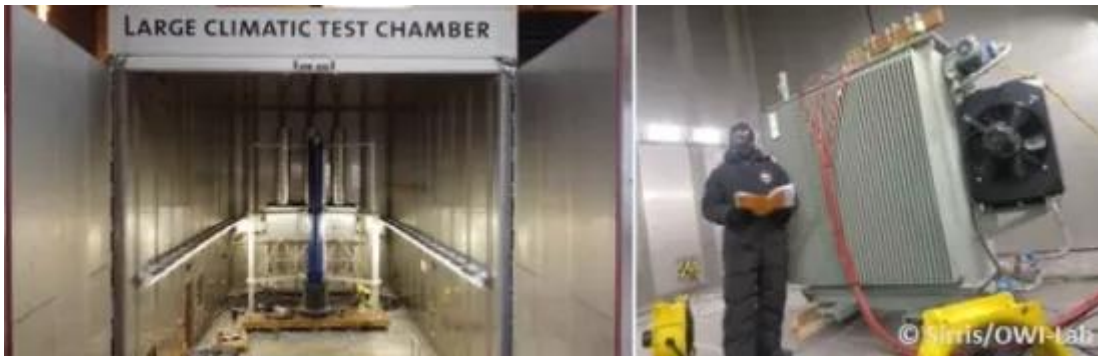
In order to remedy or prevent **temperature problems**, tests are performed under (extreme) global climatic conditions in the large climate chamber in Antwerp. This is to ensure, for example, that certain turbine components do not overheat or experience problems during a cold start. Major players such as [ZF Wind Power](#) and [Siemens Gamesa](#) tested their product prototypes in our climate chamber.

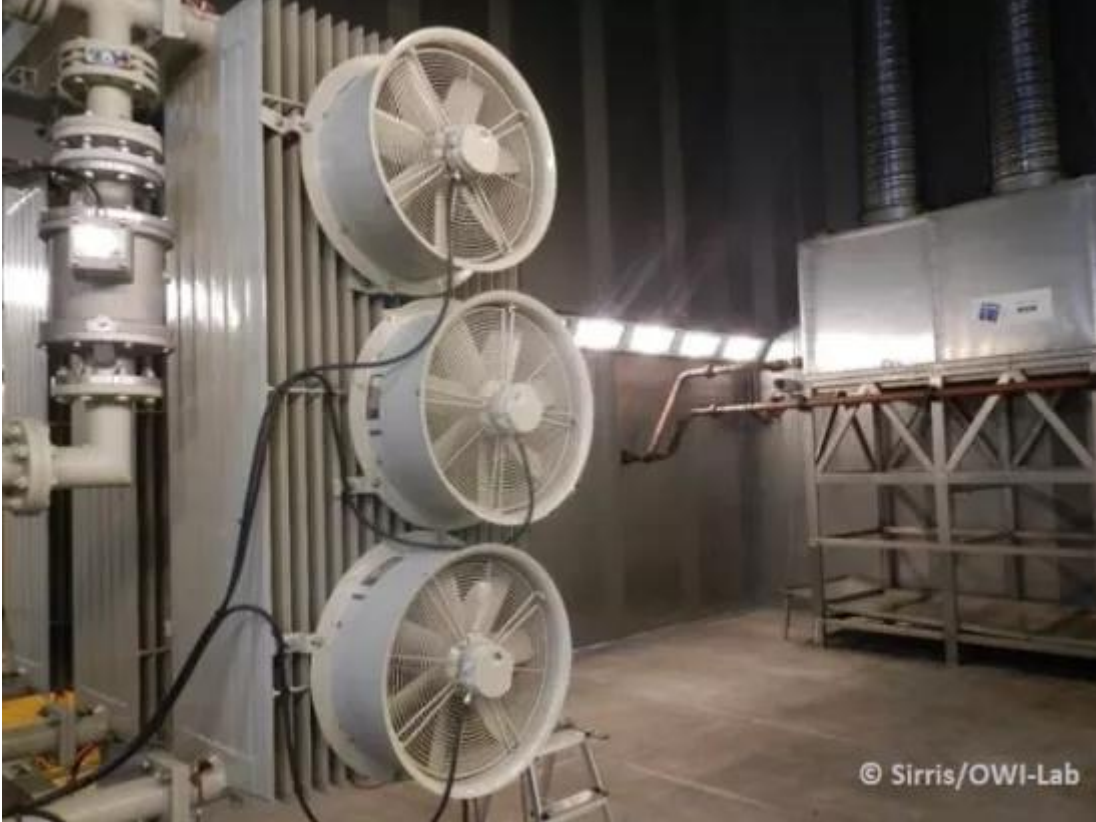
Recently, we have also been able to simulate **ice formation** in the climate chamber thanks to a new [icing test](#) set-up. Within this theme, we also have two ongoing R&D projects: [Fighting Icing](#) which translates the state-of-the-art knowledge and solutions to detect problems of icing in various domains into structured and concrete methodologies for their implementation, and [NewSkin](#) which explores the potential of nano-based surfaces for industrial and consumer products.

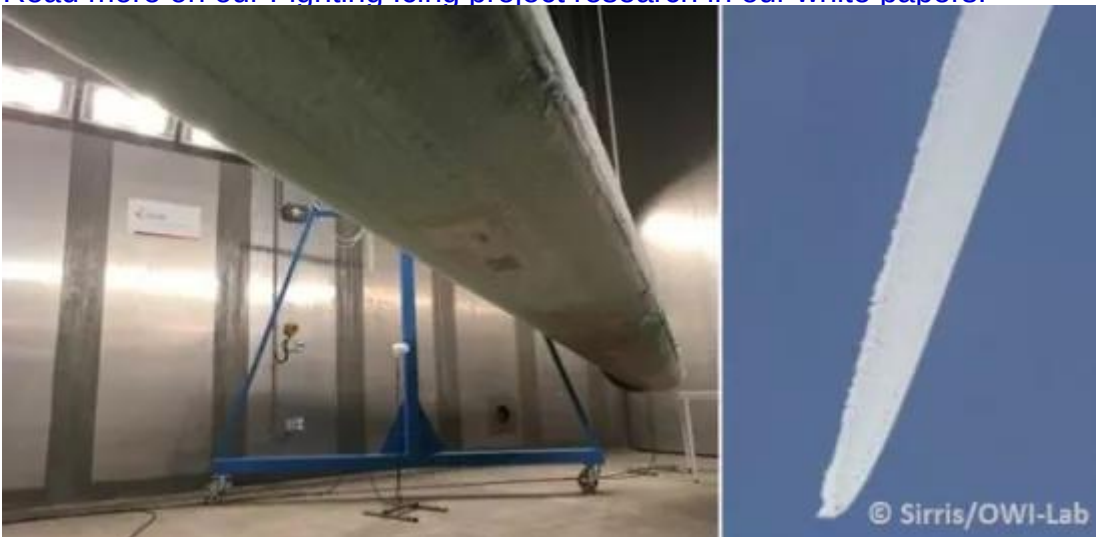
The ICON Project [Rainbow](#), finally, aims to gain a better understanding of **rotor blade erosion** caused by precipitation and lightning, as erosion causes significant production losses. This should

Harsh conditions in offshore especially frequent rain is the main reason for blade erosion

Offshore turbine's tip speed is up to 30% faster than onshore turbine

Rain droplets are larger in offshore

Fast travelling blades hitting droplets cause significant damage at the blade leading edges

Blade Leading edge erosion causes up to €1.3 million per turbine for its entire lifetime
