## The WILLOW consortium tests groundbreaking corrosion monitoring

### The WILLOW consortium tests state-of-the-art corrosion monitoring technologies that will drastically reduce maintenance and inspection costs

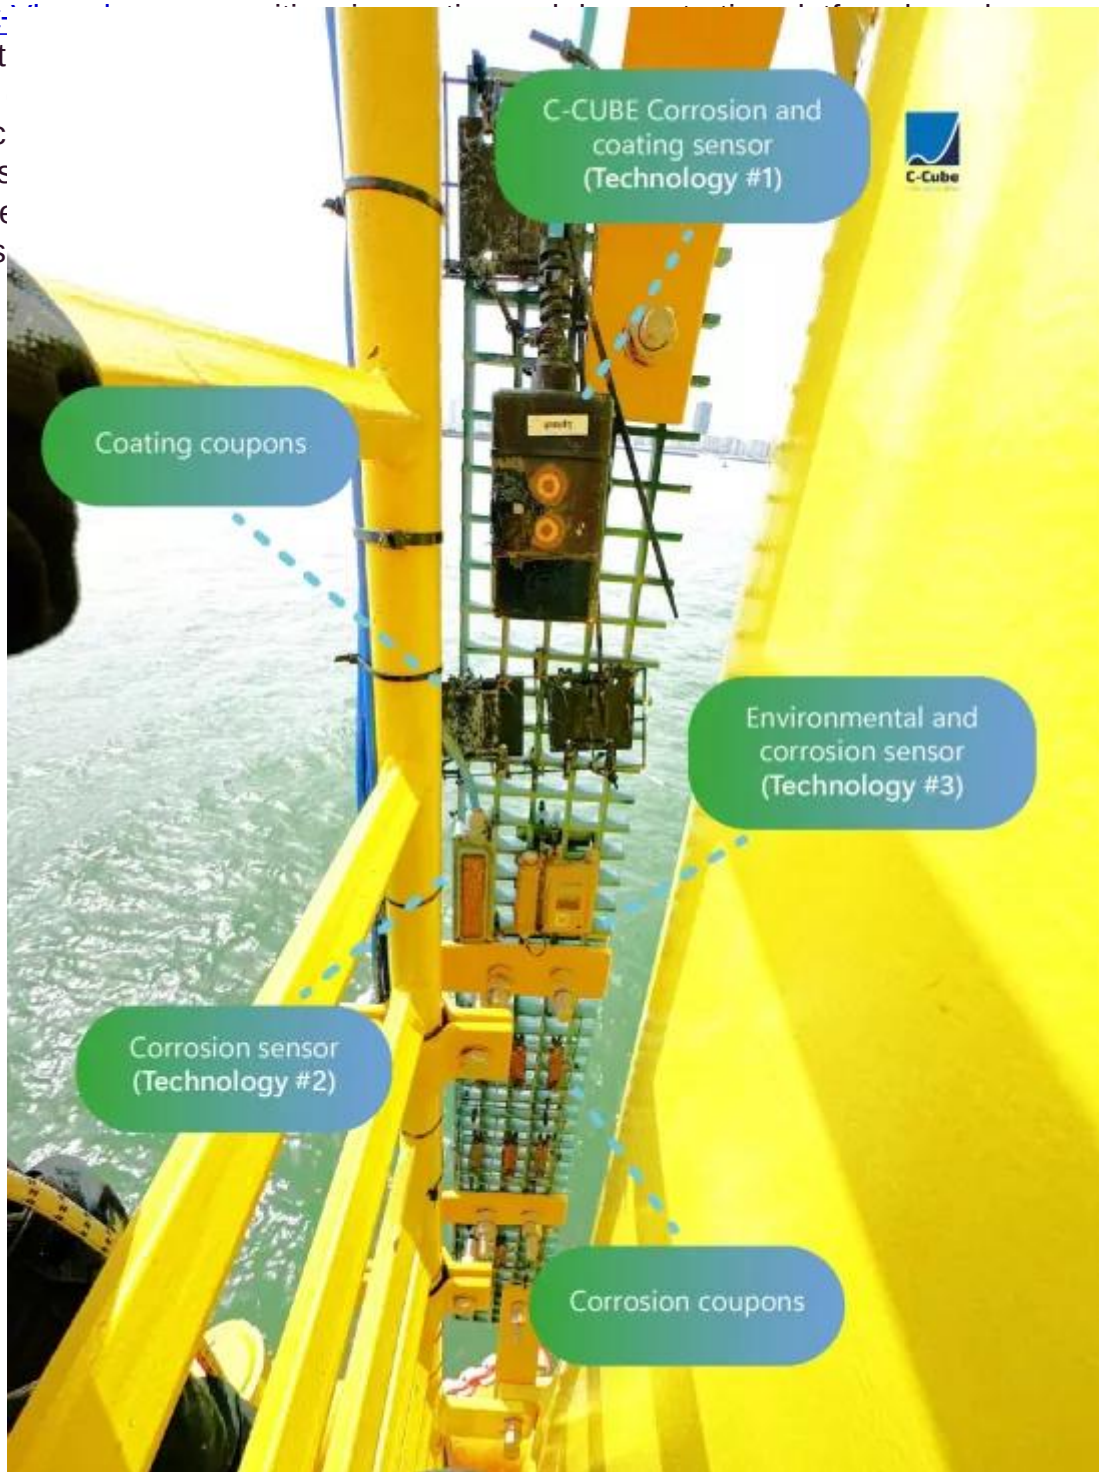
Frame in the splash zone of the Blue Accelerator monopile

One of the key use cases of the WILLOW project is the [Blue Accelerator](#) coordinated by [POM West](#). The main objective of the project's splash zone is to measure the main structural stress and corrosion, a particular stress will be measured effectively.
